May 2019

2018 Pennichuck Supply Ponds Aquatic Vegetation Assessment

Pennichuck Water Works (PWW) retained Comprehensive Environmental Inc. (CEI) to conduct a macrophyte (vascular aquatic plant) survey of the Pennichuck supply ponds during the summer of 2018. The ponds included in this investigation were Harris Pond, Bowers Pond, and Holts Pond, three connected impoundments located at the downstream reach of Pennichuck Brook in Merrimack and Nashua, New Hampshire. The primary purposes of this investigation were to:

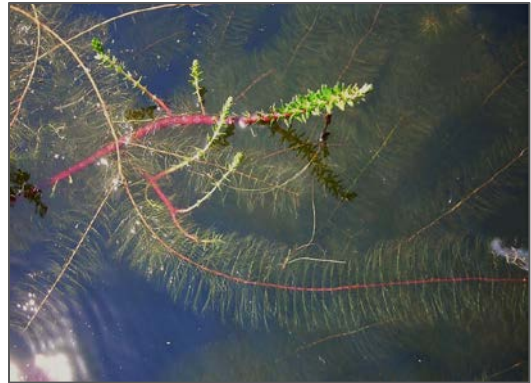
- **Variable milfoil** is well-distributed and abundant throughout Harris Pond and Bowers Pond, but was notably absent from Holts Pond. Variable milfoil was observed at 75% of the 40 combined Harris Pond/Bowers Pond monitoring stations and was a dominant plant at 50% of these stations.

Variable milfoil is a long, ropey plant with feather-like leaves that whorl around its stem, giving the plant a bottle brush appearance. This plant can grow very densely to the water surface in monoculture stands that can outcompete beneficial native species.

CEI does not recommend any plant management actions for control of variable milfoil at this time. Variable milfoil is well established throughout Bowers Pond and Harris Pond, although its abundance varies significantly based on location and depth. In general, milfoil abundance is highest throughout the relatively shallow waters in the western (upstream) portion of Bowers Pond. While moderate to dense milfoil growth occurs in other areas of Bowers Pond and Harris Pond, these areas of growth tend to be located within shallow coves or along a relatively narrow littoral zone band along the shoreline. Particularly in Harris Pond, the extent of milfoil growth is limited by water depth and the more abrupt bathymetry of the pond in its eastern section (east of Manchester Street).

Given (1) the well-established and broad area of variable milfoil growth in Harris Pond and Bowers Pond and (2) the limitations of the control options listed above, CEI recommends that the “no-action” alternative is PWW’s best option for variable milfoil at this time. We recommend that PWW continue to document changes in the pond’s plant community on a 3- to 5-year basis and re-evaluate conditions as needed, particularly for Harris Pond.

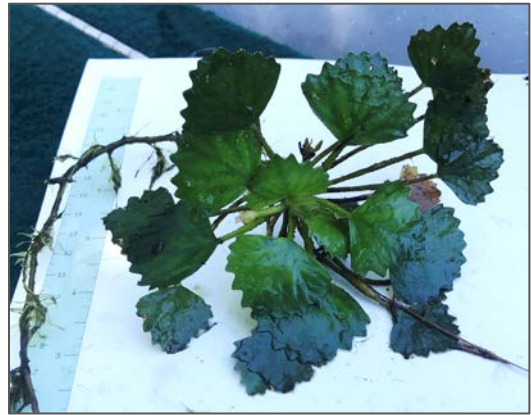
- Two **water chestnut** (*Trapa natans*) plants were observed in Harris Pond (see location in Figure 5) and were removed from the pond by CEI during the vegetation survey. This plant can be easily recognized by its distinctive “rosette” of floating leaves. Harris Pond is the only pond in this study where water chestnut was observed. CEI notified PWW of this apparently new infestation immediately following the vegetation survey.

Water chestnut is an invasive annual plant that has the ability to spread aggressively by seed dispersal once introduced to a water body. Once established, it can be extremely difficult to eradicate. Fortunately, its presence in Harris Pond seems to be very limited and recent, making control and prevention of spread much more likely with consistent efforts to identify any new plants and remove them by hand prior to seed dispersal, which typically occurs by early August. See additional discussion of control recommendations in Section 4.

It is important to recheck areas within a month after the initial handpulling to allow for removal of any regrowth or plants that were missed in the initial effort. It is highly recommended that the ponds be surveyed for water chestnut plants on at least an annual basis (in June/July) for the foreseeable future. As mentioned above, removal efforts should be completed by August, prior to seed dispersal.

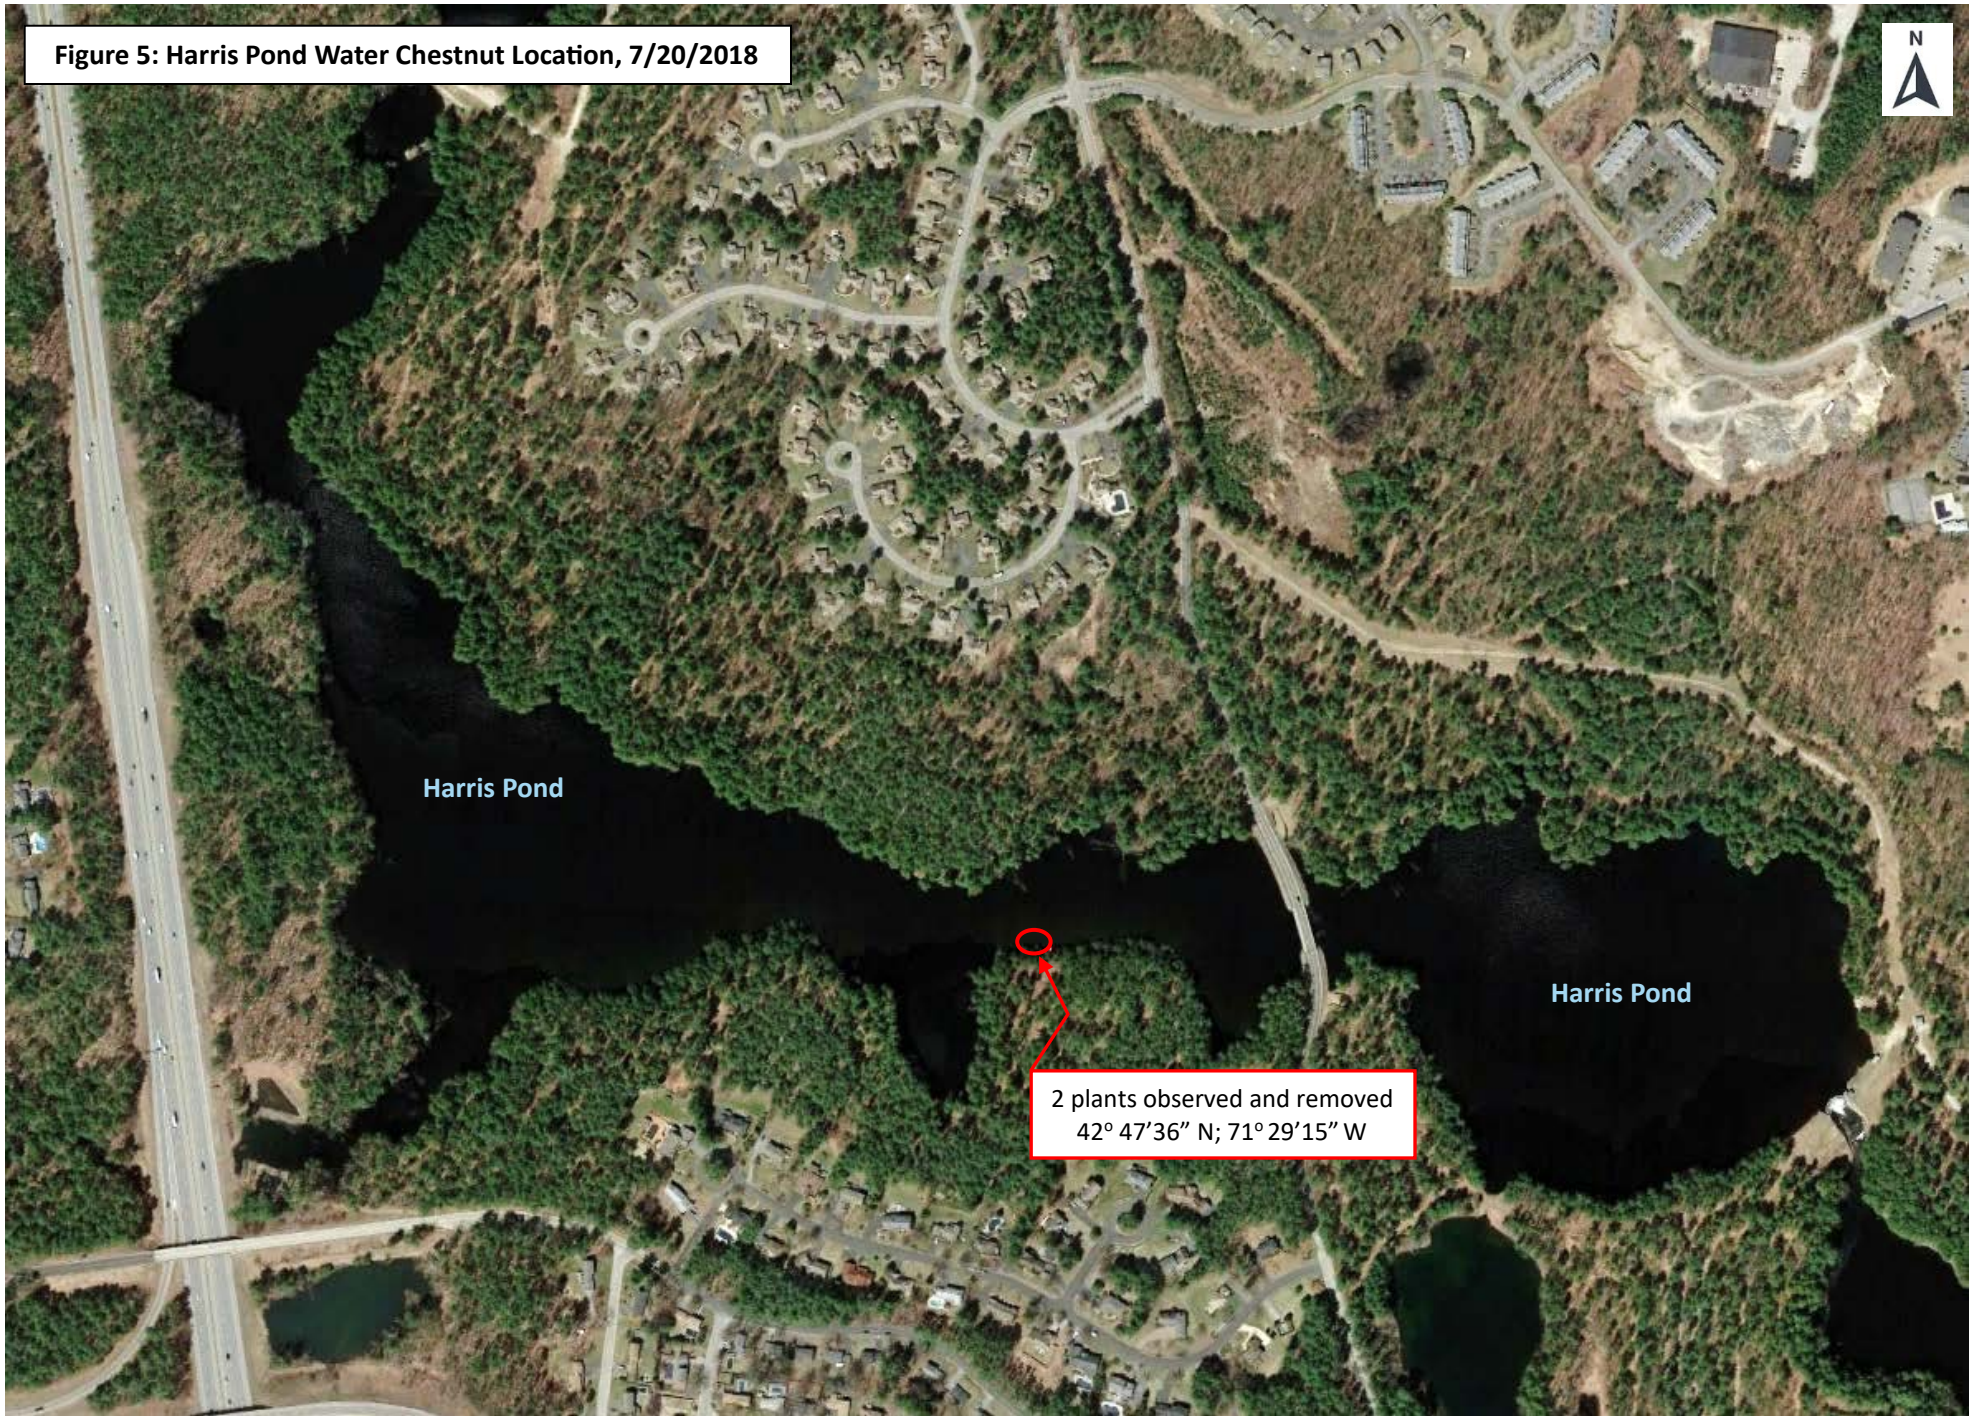
Figure 5: Harris Pond Water Chestnut Location, 7/20/2018

2 plants observed and removed
42° 47'36" N; 71° 29'15" W

As stated in Section 3.2, water chestnut is an invasive annual plant that can spread aggressively by seed dispersal. Once established, it can be extremely difficult to eradicate. Fortunately, its presence in Harris Pond seems to be very limited and recent, making control and prevention of spread much more likely with consistent efforts to identify any new plants and remove them by hand prior to seed dispersal, which typically occurs by early August.

When removing water chestnut plants by hand, it is very important to pull out the entire stem, root structure, and any attached nuts. The nuts range in color from green to black, and are easily identified by their sharply pointed spikes as shown in the photo to the right. When pulling the plants, use a very slow and steady pulling motion, taking care not to snap the stem and leave behind the nut which can produce new plants for up to 12 years. Any plants that are harvested should be disposed of in an upland area as far from the ponds as possible.

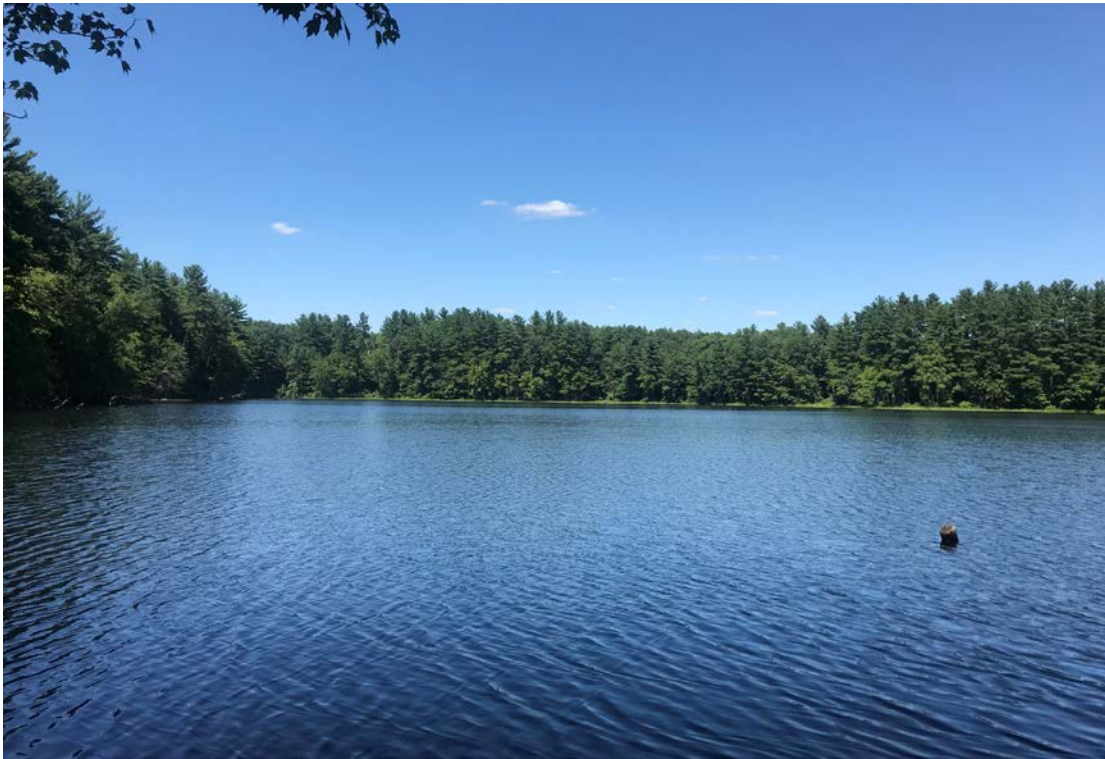
Photo 1: Harris Pond was characterized by predominantly open water with a narrow band of moderate to dense vegetation along the shoreline.

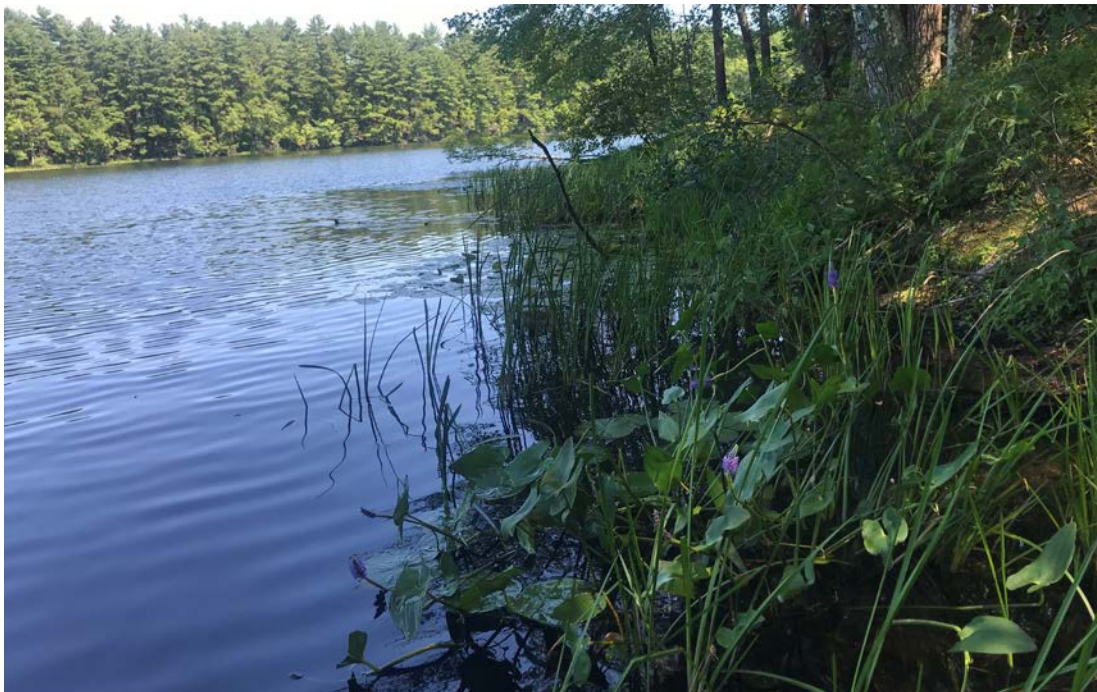
Photo 2: Typical view of emergent vegetation along the Harris Pond shoreline.

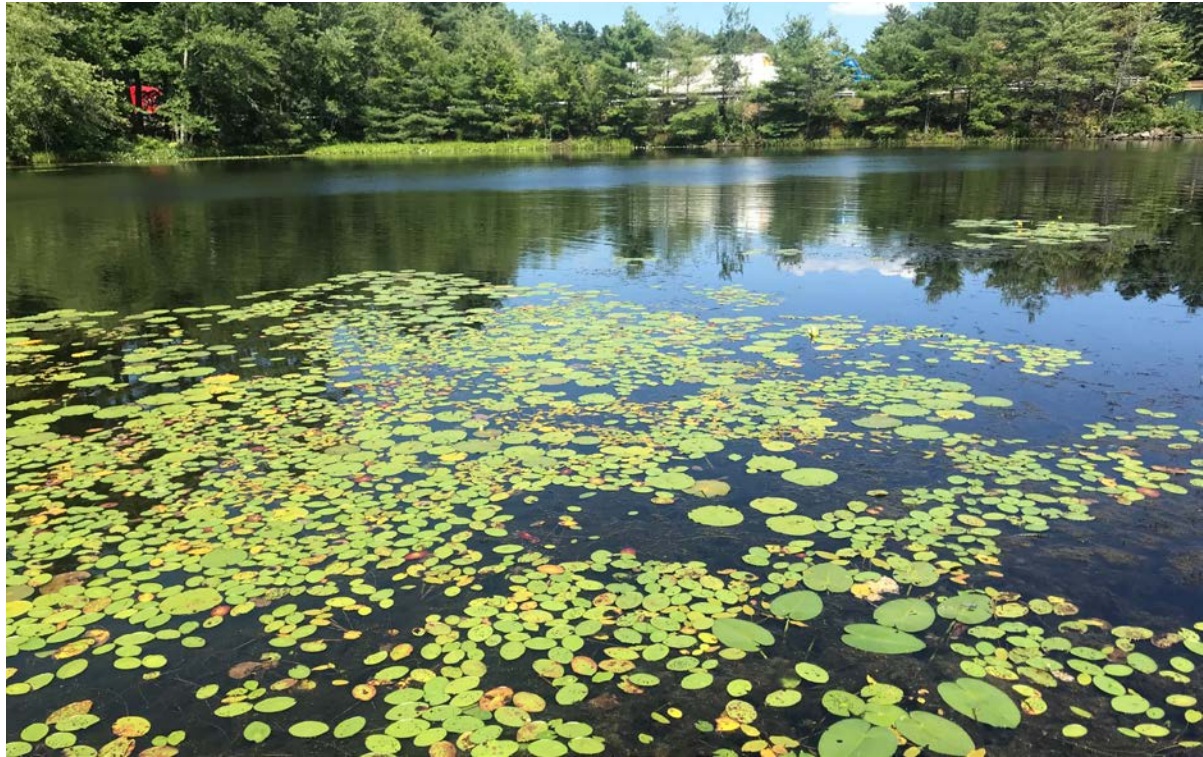
Photo 3: Typical plant assemblage in Bowers Pond, with floating leaf species (water lilies, watershield) at the surface and variable milfoil dominating in the submerged undercanopy.

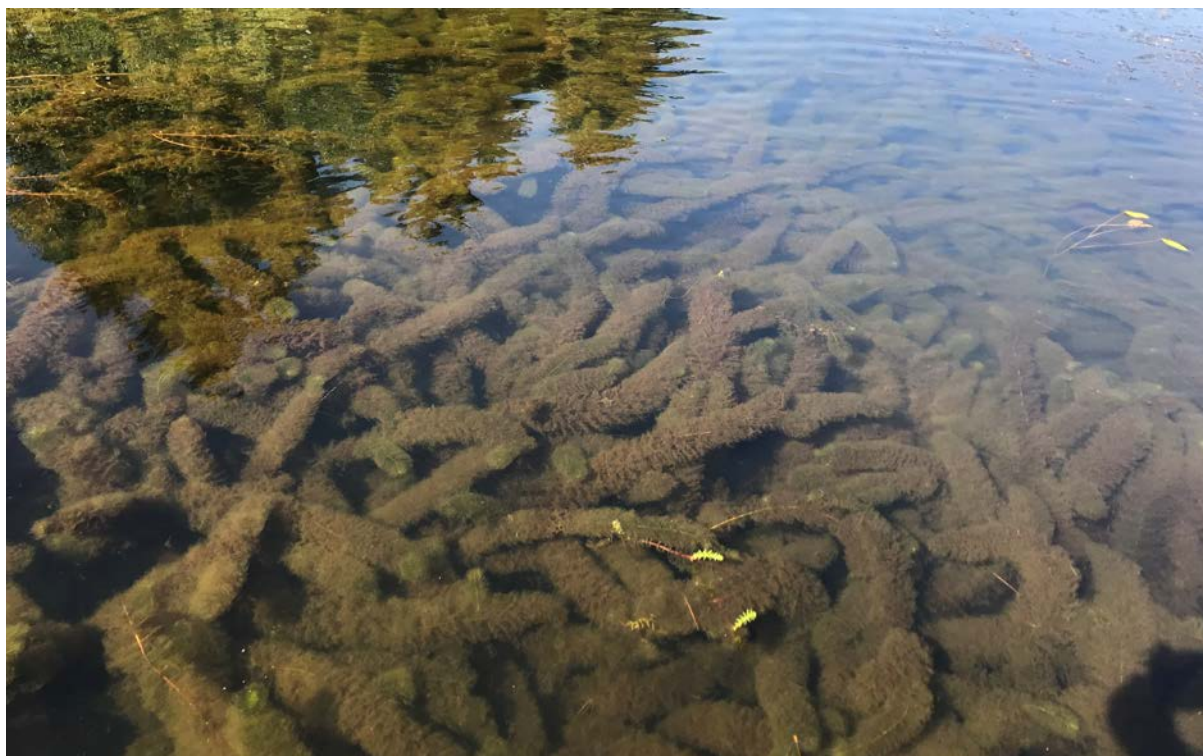
Photo 4: A very dense bed of variable milfoil in the western end of Bowers Pond.

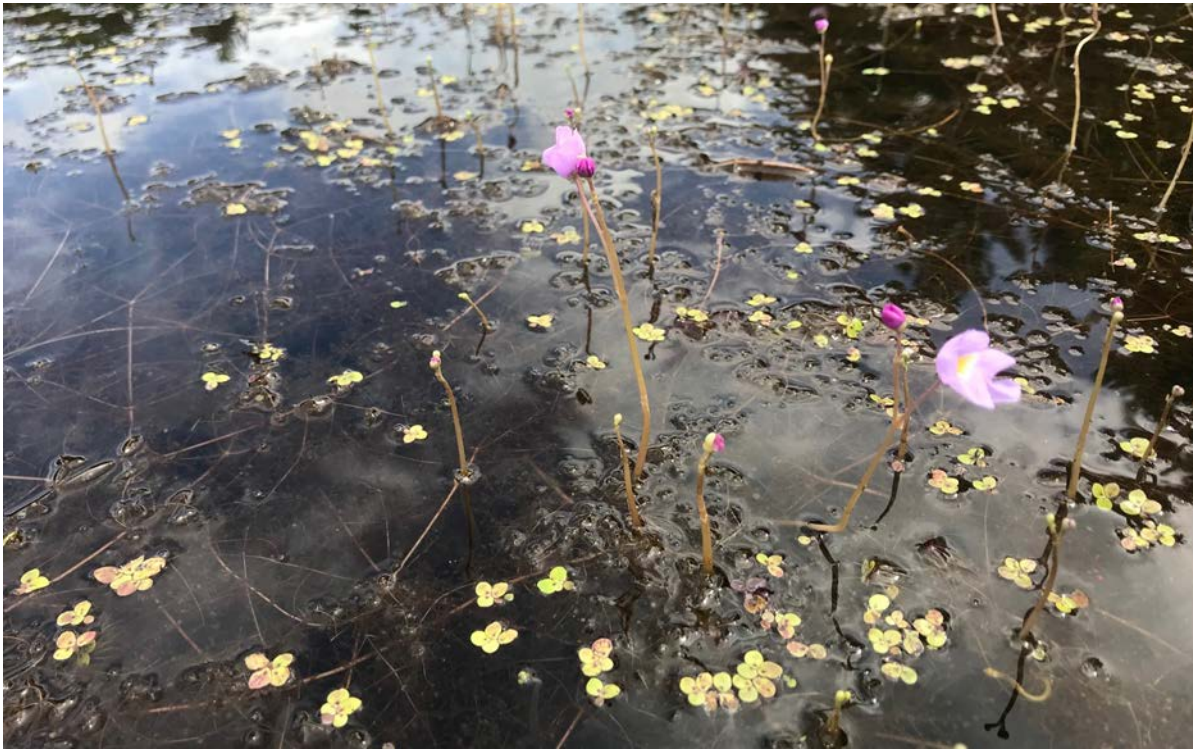
Photo 5: Purple bladderwort and greater duckweed in Holts Pond.

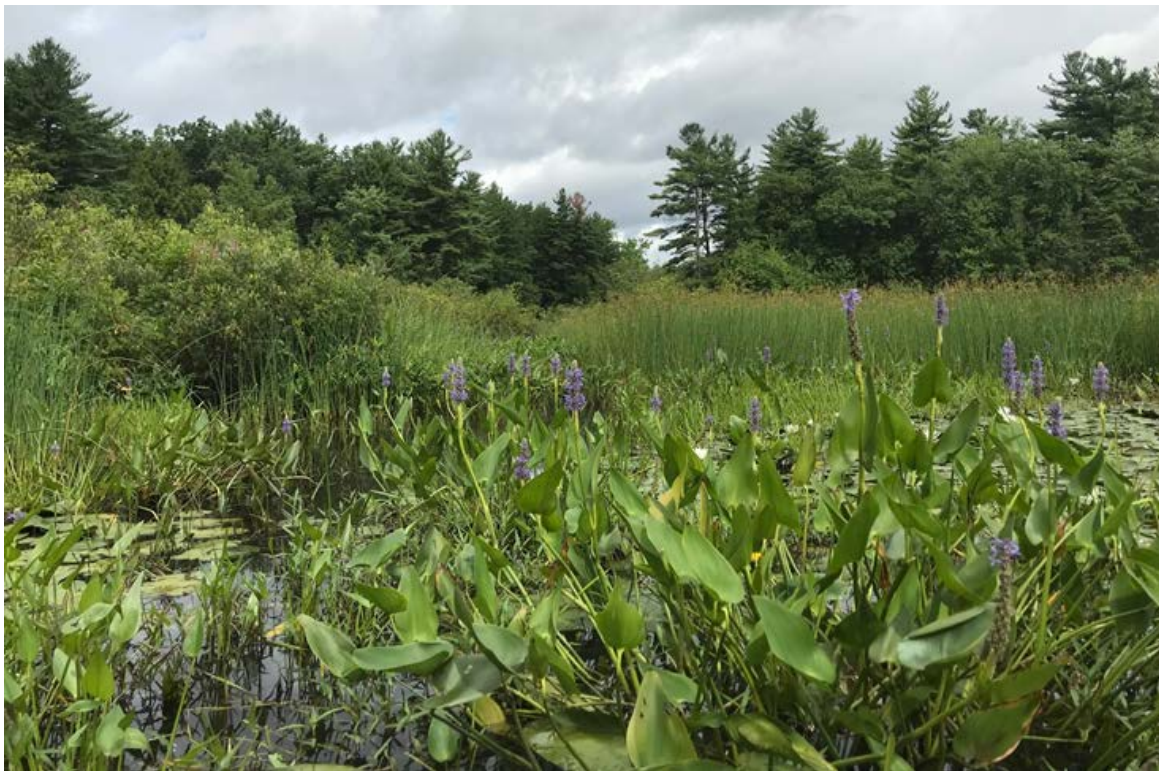
Photo 6: Abundant pickerelweed and other emergent wetland vegetation near the western (upstream) end of Holts Pond, where the pond transitions to the riverine morphology of Pennichuck Brook.

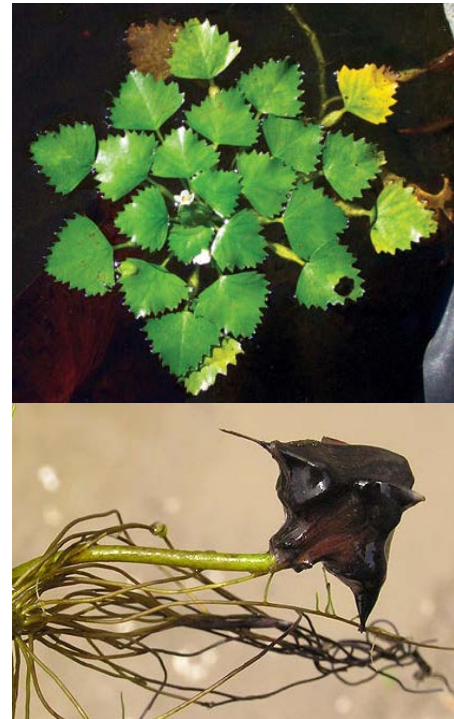
Water chestnut floating rosette (above) and nut (below).

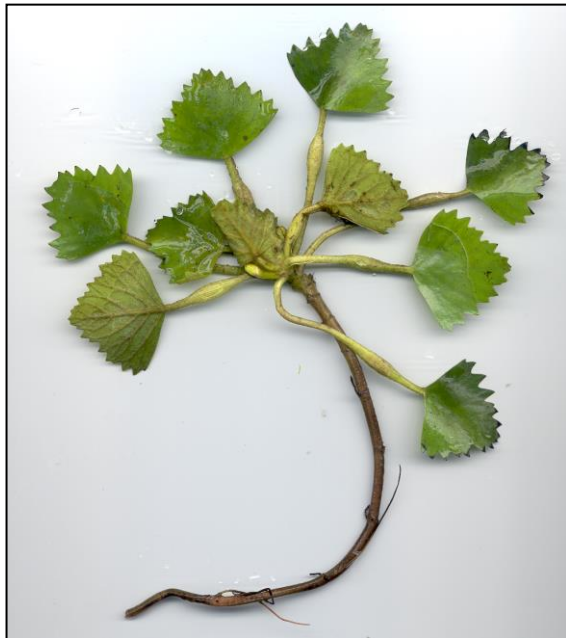
Water chestnut rosette
(*Trapa natans*)

Water chestnut can completely cover the surface of a waterbody and cause ecological hardship to native plants and animals. Fishing and boating can become extremely difficult as well. Dense strands can reach thicknesses of a foot or more.

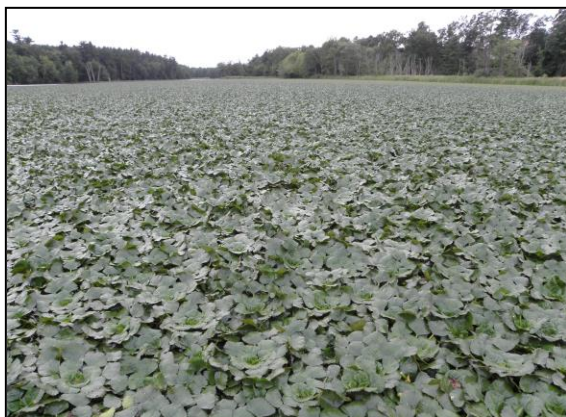
A water chestnut infestation in the Nashua River.

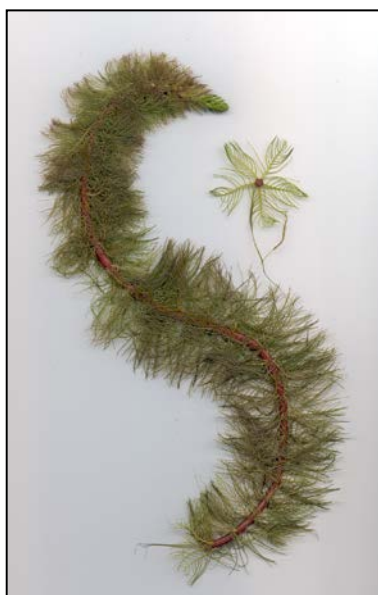
Variable milfoil *Myriophyllum heterophyllum* (Michx)

Milfoil is a submerged aquatic plant with fine, densely packed, feather-like leaves whorled around a main stem. It can grow up to 15 feet and may exhibit a three- to six-inch green spike-like flower above the waterline in late June or in July. A cross-section of the stem will reveal “pie-shaped” air chambers.
